Reed College Apartments

5510-5522 SE 28th Avenue

Project Summary

Overview of the Stormwater System

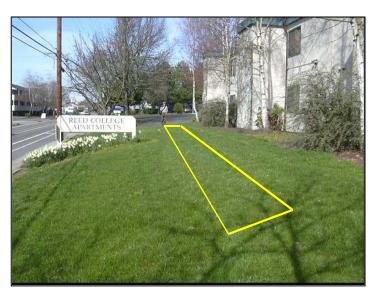
Outline of soakage trench along the front of the Reed College Apartments - SE 28th is to the left. Not to scale.

- The top of the soakage trench is approximately 2.5 ft. below grade; it is covered with soil, and the ground surface is seeded with grass.
- The trench is slightly deeper and wider than recommended by the SWMM: it is approximately 125 ft. long, 5 ft. wide, and about 3.5 ft. deep. It is lined with filter fabric.
- There are three layers of material in the trench:
 - o 12 inches of drain rock (top layer)
 - o filter fabric
 - o 18 in. of sand (bottom layer)
- Flow enters the system through a perforated pipe that travels horizontally along the top of the layer of drain rock.

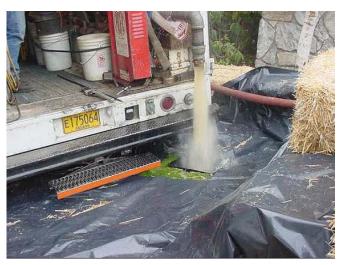
Flow test - City staff simulated the peak of the 25-yr. storm (hydrant water was injected into the silt basin); 2002

- The trench is 15 ft. from the closest building foundation; it is 20 ft. from the public right of way.
- Flow test: After completion of the project, City staff tested the facility's ability to accept the 25-year storm. To mimic peak flows, a hose passing 380 gpm was introduced at the top of the silt trap after 5 minutes of moderate flows. No problems were observed during the two-minute interval during which the peak rate was applied. The system received a total of 3,900 gallons in 13 minutes (note: the facility has an interior capacity greater than 5,000 gallons).

Flow tests have documented the ability of the soakage trench to accept the peak of the 25-year storm.
